Quality Assurance and Source Inspection

Contract #: 04-0120F4Cty: SF/ALA Rte: 80 PM: 13.2/13.9File #: 69.28**WELDING INSPECTION REPORT****Resident Engineer:**Pursell, Gary**Address:** 333 Burma Road**City:** Oakland, CA 94607**Report No:** WIR-003324**Date Inspected:** 20-Jul-2008**Project Name:** SAS Superstructure**OSM Arrival Time:** 700**Prime Contractor:** American Bridge/Fluor Enterprises, a JV**OSM Departure Time:** 1730**Contractor:** Zhenhua Port Machinery Company, Ltd (ZPMC), Changxing Island **Location:** Shanghai, China**CWI Name:** Keng Chan**CWI Present:** Yes No**Inspected CWI report:** Yes No N/A**Rod Oven in Use:** Yes No N/A**Electrode to specification:** Yes No N/A**Weld Procedures Followed:** Yes No N/A**Qualified Welders:** Yes No N/A**Verified Joint Fit-up:** Yes No N/A**Approved Drawings:** Yes No N/A**Approved WPS:** Yes No N/A**Delayed / Cancelled:** Yes No N/A**Bridge No:** 34-0006**Component:** Tower**Summary of Items Observed:**

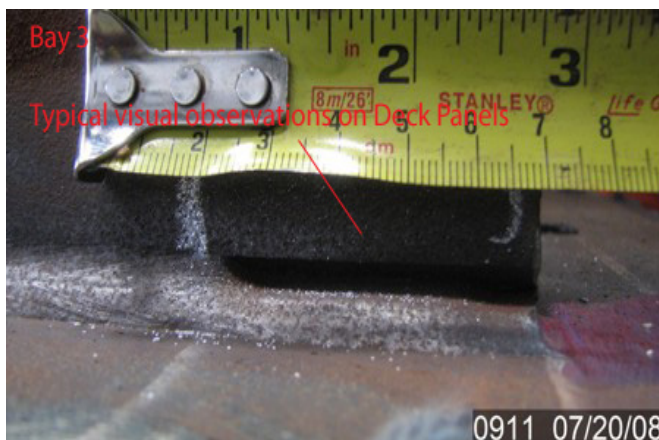
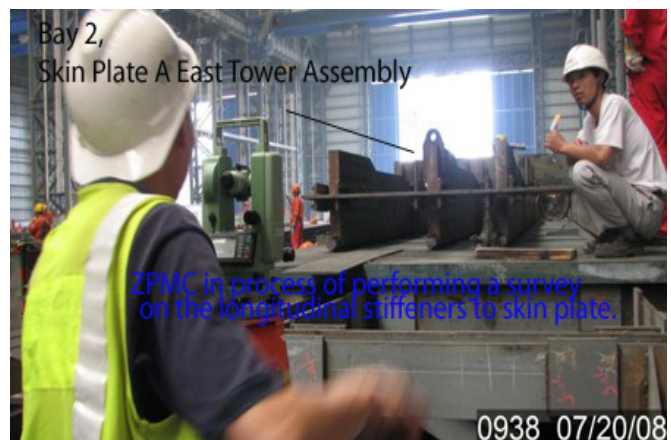
The Quality Assurance Inspector performed a random initial visual observation on Orthotropic Box Girder (OBG) DP-044-001. The Quality Assurance Inspector observed several areas of under fill and undercut. ZPMC and American Bridge/Fluor Quality Control Inspector agreed with the visual observations found by the Quality Assurance Inspector. ZMPC Quality Control Inspector informed the Quality Assurance Inspector, he will contact the Quality Assurance Inspector when the repairs are complete.
